RESEARCH ARTICLE

Factors in The Deterioration of Social Housing in Central African Cities: The Case of Malabo in Equatorial Guinea

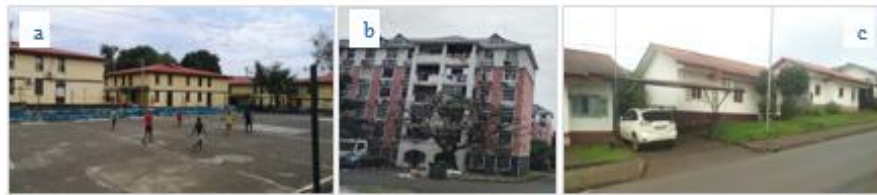
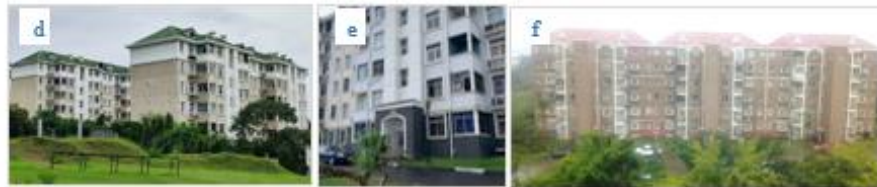
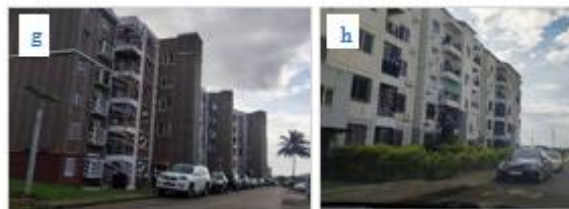
Photographic plate 1: Overview of surveyed properties

(a) Quartier Los Angeles, (b) Sipopo, (c) Buena Esperanza I

(d) San Juan, (e) Vigatana, (f) Arab Contractors

(g) Malabo II, (h) Paraiso

These photos illustrate the richness and heterogeneity of social housing production in the city of Malabo. The Los Angeles (a) and Buena Esperanza (c) housing estates do not have the same high ceilings as the other estates (b, d, e, f, g, and h). These are the first two to feature ground- and first-floor units (RDC and R+1). But in the Vigatana housing estate, there's only a small share of the 36-unit RDC for the middle class. Finally, it should be pointed out that although most of these housing estates are built to a height of R+5, access to housing is not discriminatory, but you do need to be solvent, i.e. a certain guarantee of average income or a deposit from your employer.

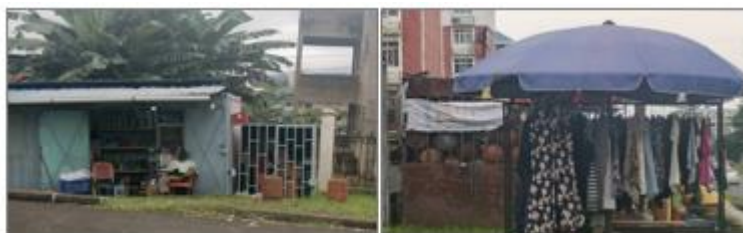
Photographic plate 3 : Illegal occupation of the Vigatana B housing estate

Photographic plate 3 shows a summary of the most representative activities on the streets of Malabo's social housing estates, i.e. the occupation of sidewalks by commercial activities. Observations in the field have revealed the proliferation of informal economic activities, often carried out outside any legal control. These

activities can be detrimental to the safety and well-being of residents, creating a lack of places to entertain and socialize, as well as difficulties in accessing residents and emergency services.

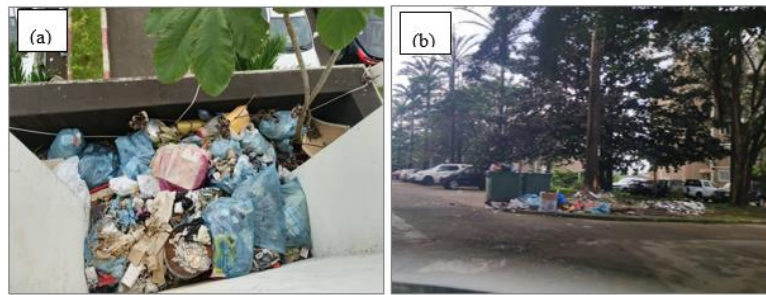
Photographic plate 4 : Presence of household waste in housing estates

Photographic plate 4 illustrates the illegal dumping of solid waste here and there in the streets of Malabo's social housing estates. This situation is due to the financial constraints faced by the National Real Estate Management Entity of Equatorial Guinea (ENPIGE). This finding reveals a lack of environmental awareness and consciousness among residents, which translates into anti-social practices, etc. Indeed, garbage is sometimes thrown out of windows or deposited directly in the street. This behavior leads to olfactory and visual pollution, which is detrimental to people's health. Today, this requires citizens to recognize their rights and duties when it comes to the proper use of the city.

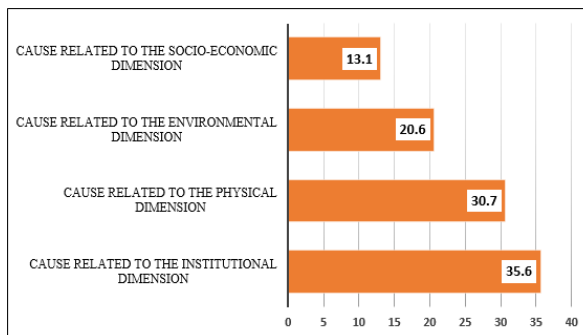
Figure 3 : Causes of social housing deterioration in Malabo

The institutional dimension is the primary cause of social housing deterioration in Malabo (35.6%). In particular, it highlights the absence of a mechanism for producing adequate social housing. This has led to neglect of existing regulations, which are decisive factors in the implementation of a social housing project. This lack of a single entity is reflected in inadequate coordination between the players involved, i.e. the Ministry of Public Works, Housing and Urban Planning (MOPVU), GE-Proyectos, the construction company, ENPIGE and others. Institutional failure not only fosters inefficient design and construction processes, but also creates an environment conducive to inappropriate building practices. This situation can also be explained by the lack of material, financial and human resources to tackle the problem head-on.

The physical dimension was considered by 30.7% of respondents to be the second most important cause of social housing deterioration in Malabo. The main factors identified in this category are defects in housing design and installation. These shortcomings often manifest themselves in the poor orientation of buildings and the use of unconventional construction methods that are unsuited to the environment, which accelerate the ageing of structures and tend to compromise their safety and comfort. On the other hand, professionals admit that these defects are often the result of incomplete planning and inadequate supervision, aggravating the structural condition of homes in the long term.

The environmental dimension is another significant cause of social housing deterioration in Malabo, accounting for 20.6% of respondents. The factors put forward point to the need to take account of climatic and geotechnical conditions specific to the various construction sites. Lack of adaptation to local environmental characteristics, such as resistance to extreme climatic conditions and/or geotechnical stability of the buildings' load-bearing structures, makes them vulnerable to deterioration. For example, the Arab contractors and Malabo II housing estates face the problem of damp rainwater, as do the drinking water supply and flushing systems. There is also the problem of soil compaction facing the abandoned Sipopo housing estate. This area, which was once used as a landfill site, has not been backfilled or compacted in any significant way. This information was verified through field observations.

Finally, only 13.1% of professionals believe that the deterioration of social housing in the city of Malabo is attributable to the socio-economic dimension. In particular, they point to inappropriate use of space by residents, often linked to illegal alterations caused by residents' negligence, and to economic constraints that limit their ability to maintain their homes in good condition. It should be pointed out that over 10% of occupants say that the socio-economic dimension is also at the root of the lack of maintenance in their homes.
