RESEARCH ARTICLE

Geomorphological Characterization from the Geographical Perspective of the Yunganza Zone Limón Indanza, Ecuador

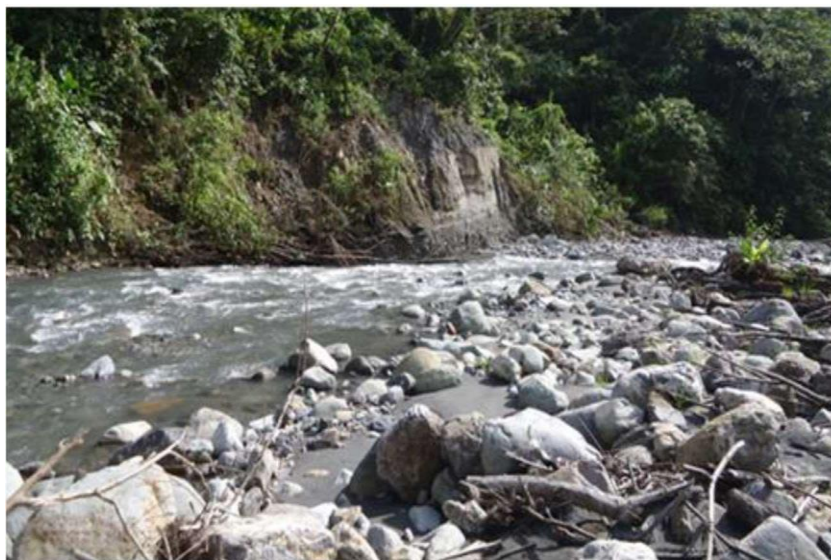
Figure 5: Cumtza River, left bank, rocks of the Mesa Fm

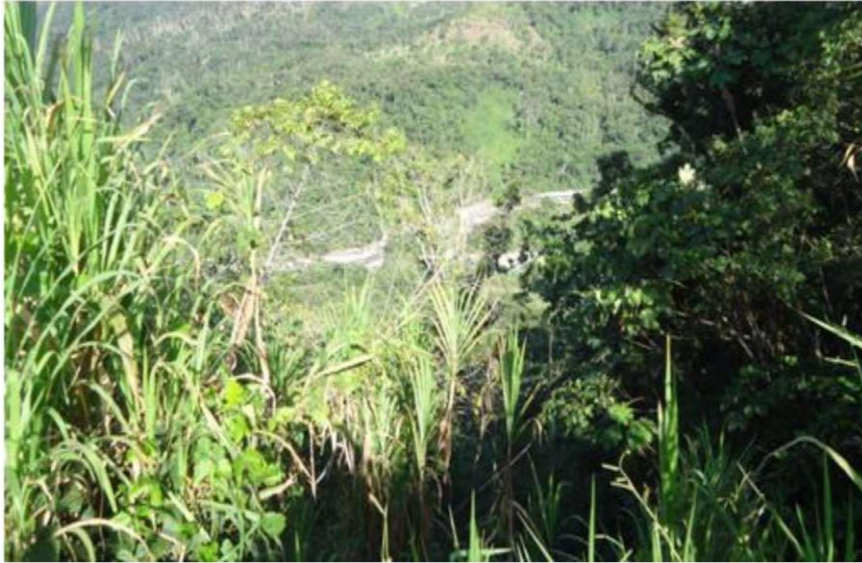
Figure 6: View of the Yunganza river valley

This geoform is present on the plateau above the road where the Technical University of Yungantza is located, resting on the rocks of the mesa formation, affected by ground movements.

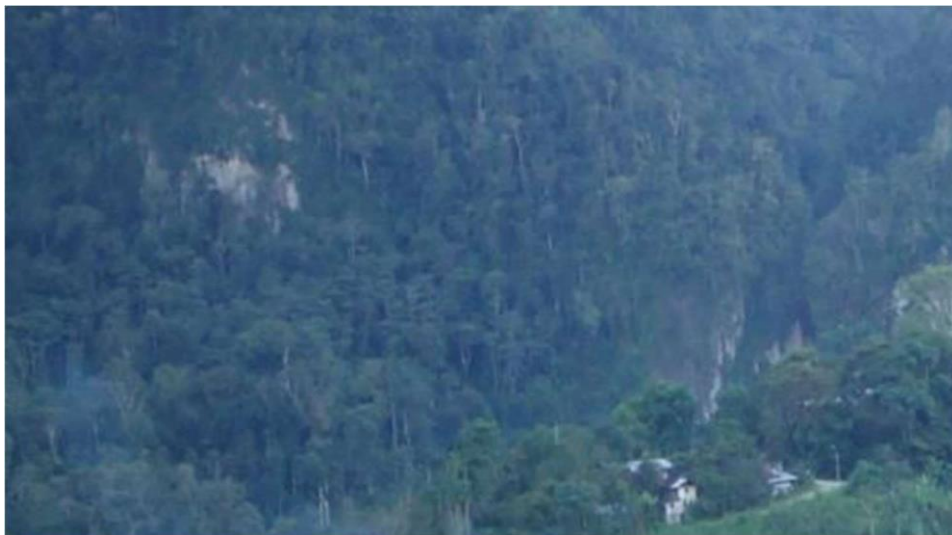
Figure 7: Tectonic scarps in andesites

Located in the southern and eastern regions, this area exhibits steep slopes and vertical incisions, especially notable in the Misahuallí volcano. These features originate from tectonic movements linked to faults present in the geological activity of the region.

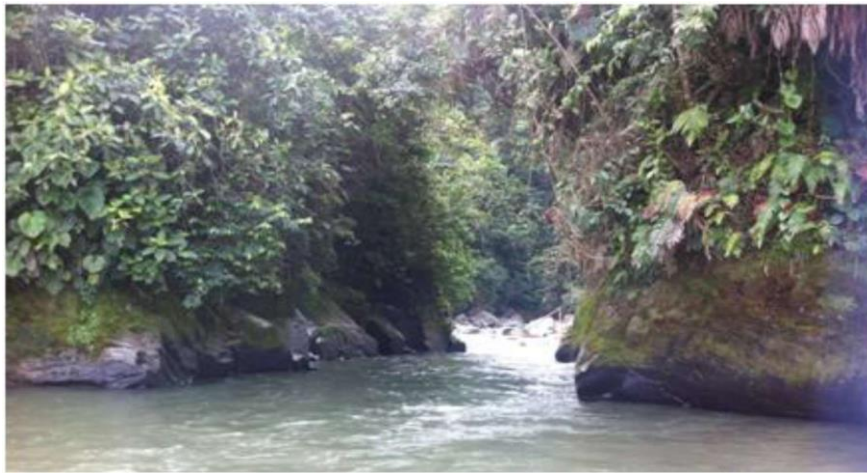
Figure 8: Engraved characteristics of the Yungantza riverbed

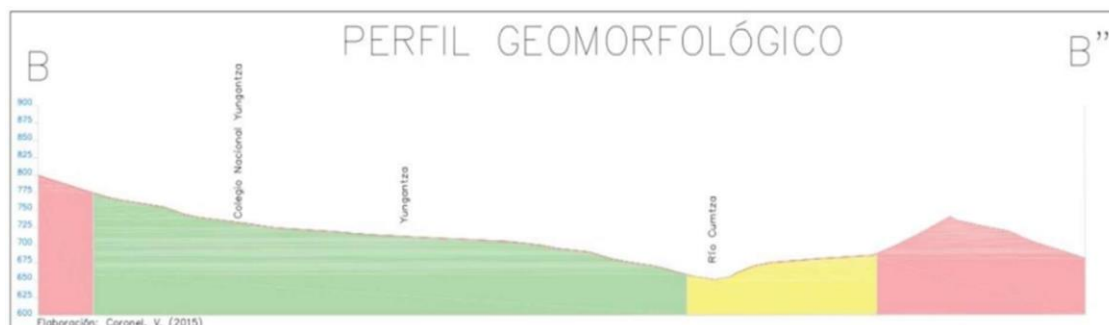
Continuing with the geomorphological profile "B-B", which starts at 9'693.950N, 792.650E and extends to 9'682.540N, 792.600E, crossing the Mesa Formation zone to the northwest of the area affected by the Yungantza landslide, illustrating the geomorphological relationships of this phenomenon.

Figure 10: Geomorphological Profile B-B"

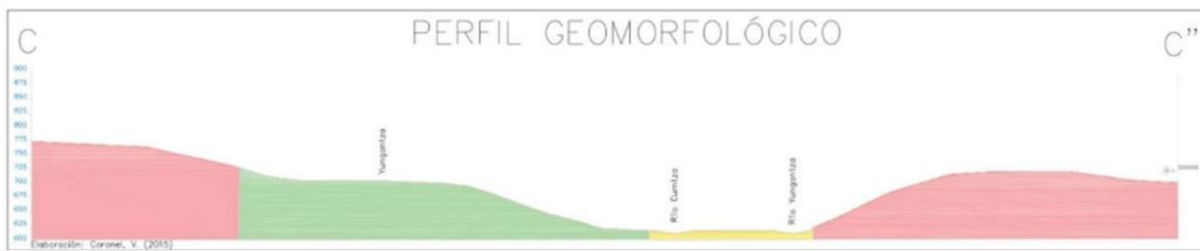
Finally, the Troncal Amazónica defines the C-C topographic profile that runs from 9°683.620N, 792.000E to the eastern edge, revealing a north-south slope formed by a significant landslide towards the Cumtza river. This profile describes the relationship between landslides and rock formation in the region.

Figure 11: Geomorphological Profile C-C''
