RESEARCH ARTICLE

Analysis of the Impacts of Irregular Development of Hillside Areas and Water Erosion in Brazzaville, Republic of Congo: The Case of Quartier Don Bosco in Arrondissement 9 Djiri

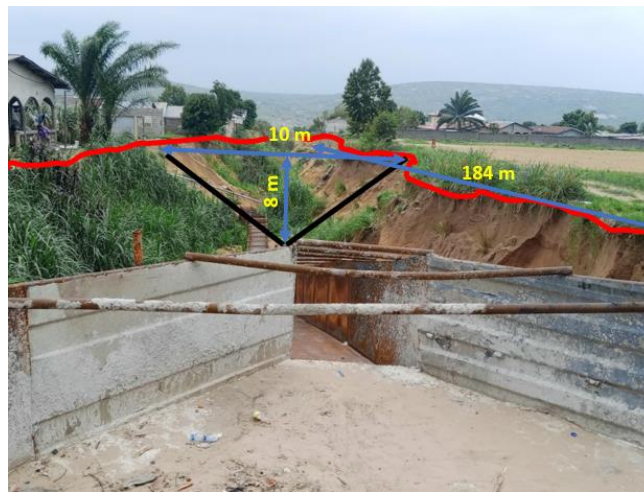
Photo 1: Measurements of gully section 1 (2023-2024)

This photo illustrates the exercise of taking different measurements of the ravine, for example in section n°1, corresponding to the period 2023-2024. This is how we obtained the quantification data for this gully.

The data obtained from the three-dimensional measurements of the ravine have enabled us to identify three periods of its evolution: 2012-2022, 2022-2023, and 2023-2024 (Table 1). The main measurements are the width and depth of the section and length of the gully for each period analyzed (Photo 1).

N°	Periods	Width (m)	Depth (m)	Section (m^2)
1	2023-2024	10	8	40
2	2022-2023	20	15	150
3	2012-2022	45	20	450

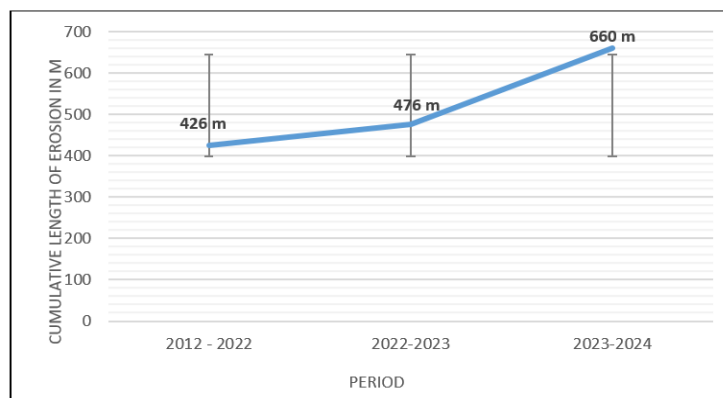
Figure 6: Evolution curve of the gully between 2012 and 2024

The evolution of the head of the Don Bosco ravine by recession was remarkable and exponential over the period from 2023 to 2024 (Figure n°6), due to the exceptional rainfall recorded in 2023.

This evolution, which reflects the intensity of erosion in the study area, results in a considerable cumulative soil loss of 211,200 m³, for a surface area of 1.8 ha, i.e. 117.33 t. ha⁻¹.

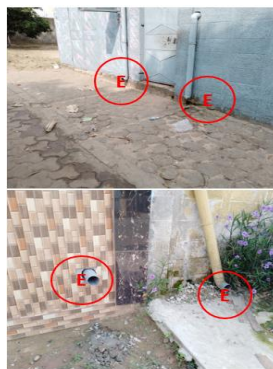
Plate 1: Gutters draining rainwater into the street

E- Rainwater drainage pipes.

The photos above show rainwater drainage pipes oriented towards the street.

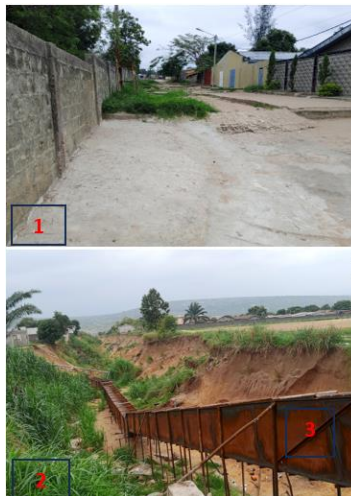
Plate 2: Landscaped street ending in the Don Bosco ravine (Itatolo neighborhood, Djiri)

The main avenue of the Don Bosco housing estate is in its undestroyed part, 1,100 metres long, starting from national road no. 2 (RN2), where erosion by gullyng is triggered by the concentration of runoff water. It is paved with cement cobblestones for 750 metres and is built on a 13.5% slope leading directly into the ravine (Photo no. 2).

Legend: 1- Avenue of the Don Bosco Institute (1,100 m), leading to the ravine; 2- Ravine de Don Bosco; 3- Water channeling structure.

The Don Bosco ravine develops along this avenue in a regressive dynamic, starting from the talweg of one of the branches of the Itatolo river, towards the main road n°2. It is one of Brazzaville's active ravines. In its upper reaches, it progressed over a length of 234 m, with a width of 10 m and an average depth of 8 m between 2022 and 2024. As it progressed, it swept away the 194 m-long boundary walls of the Don Bosco complex. All in all, the gully developed, as outlined above, over a length of 660 m between 2012 and 2024, washing away 14,910 m² of built-up area, i.e. 37 plots.
